# DRAFT REPORT

## 105A Avenue Improvements: Whalley Boulevard to 144 Street

### Environmental Impact Assessment

**Hemmera Envirochem Inc.**

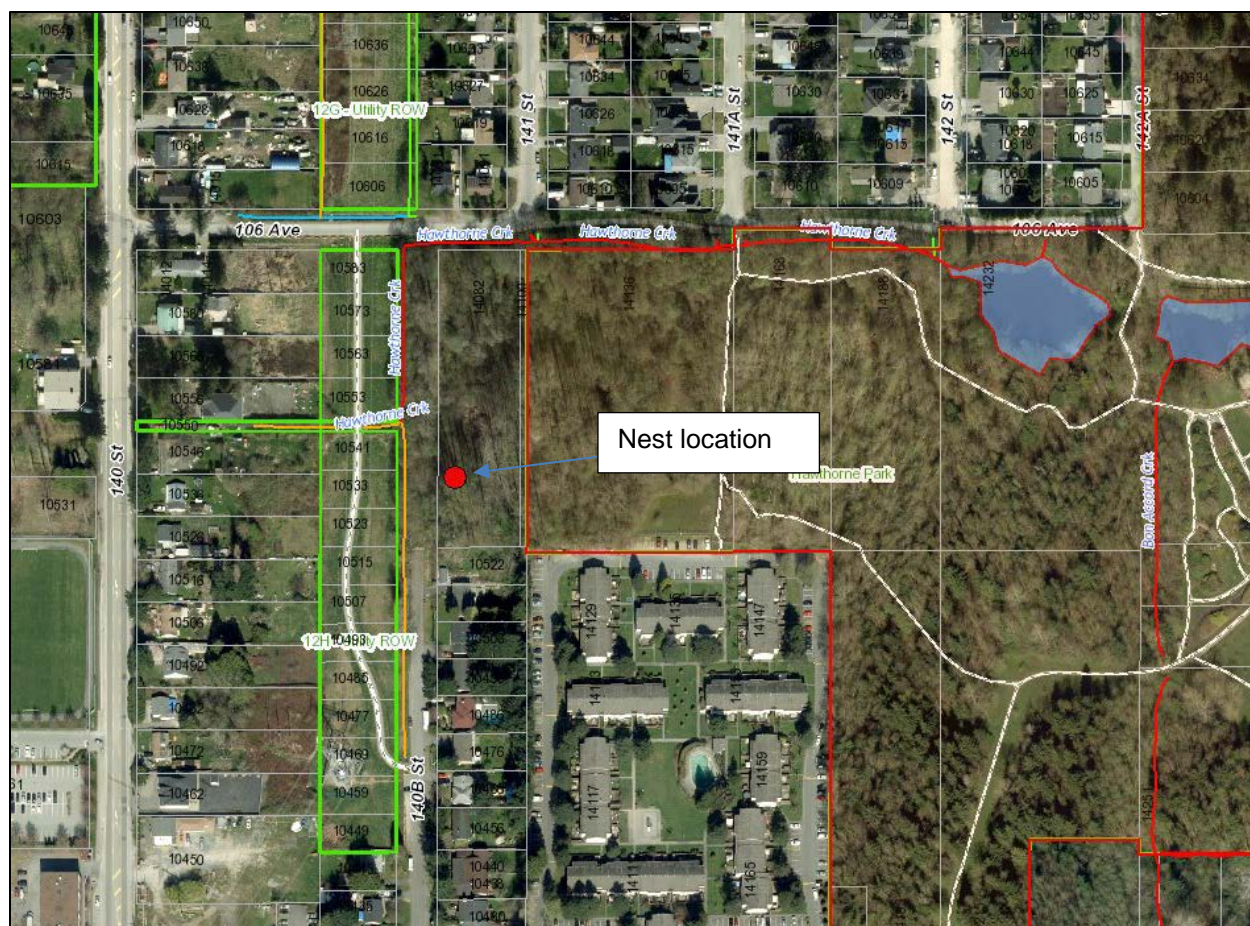
**Figure 5 Location of Stick Nest**

Suitable songbird nesting habitat is available throughout the forested areas of the study area, as well as in several of the hedges and ornamental trees found on residential properties within the study area. Several songbirds were observed in the study area including American robin (*Turdus migratorius*), dark-eyed junco (*Junco hyemalis*), song sparrow (*Melospiza melodia*), and black-capped chickadee (*Poecile atricapillus*). The BC Hydro ROW represents suitable foraging habitat for several species of birds, including raptors such as owls and hawks, which may hunt for small mammals along the ROW. No bald eagle (*Haliaeetus leucocephalus*) or osprey (*Pandion haliaetus*) nests are recorded by the WiTS (2017) within the study area, however a large stick nest, likely a red-tailed hawk (*Buteo jamaicensis*), was noted on the west side of the park at the north end of 104 B Street within a cottonwood tree (**Figure 5, Appendix B-2, photo 5**).

**Photo 5:** Stick nest in cottonwood.

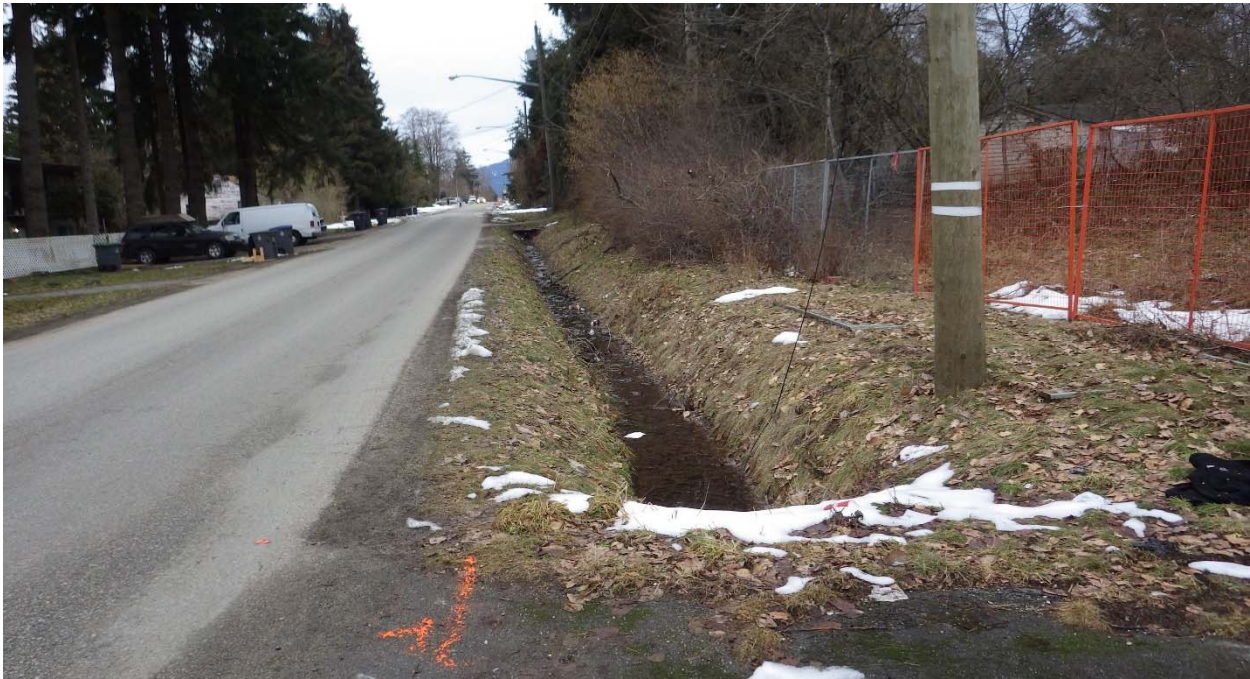
**Photo 1:** View of 139 Street east ditch (Class C) near proposed new road alignment, facing north.

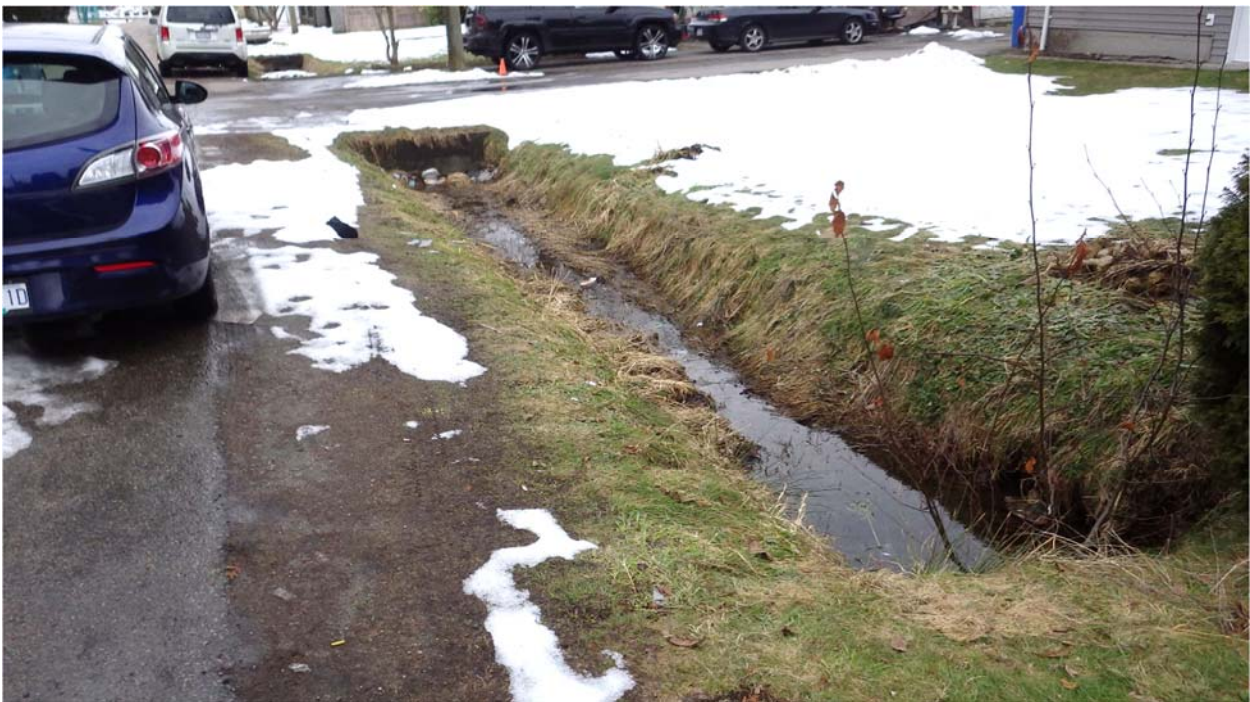
**Photo 2:** View of 138A Street east ditch (Class C) near proposed new road alignment, facing north.

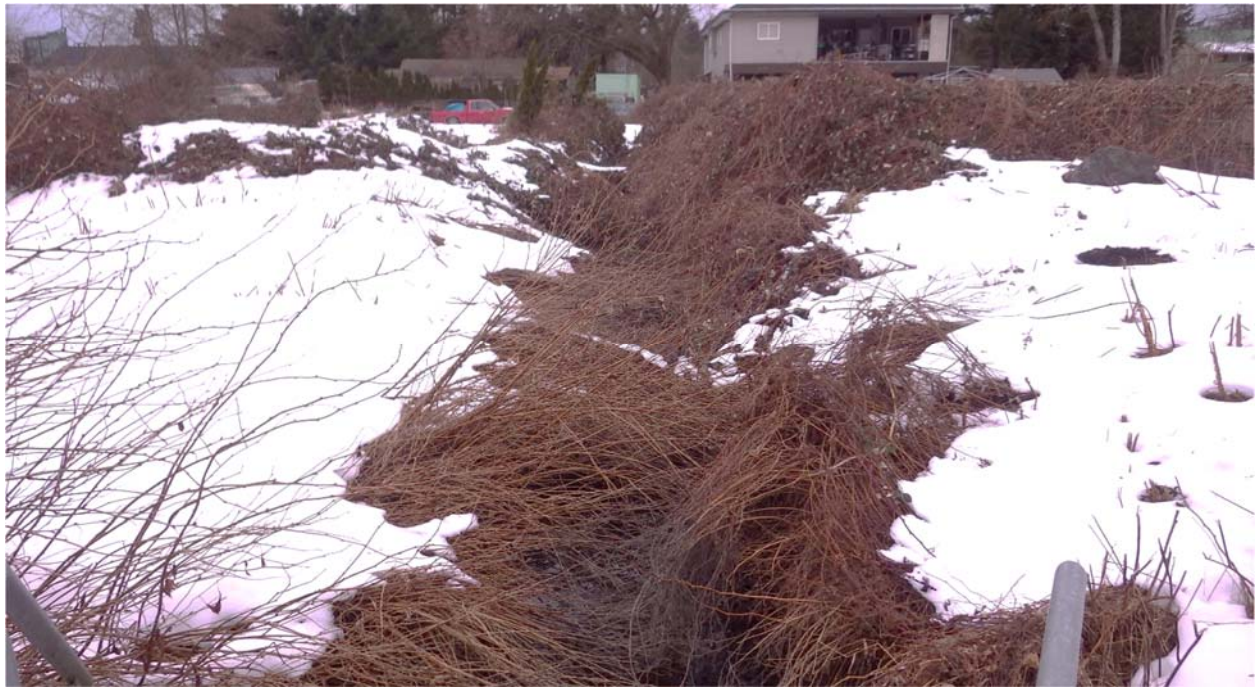
**Photo 3:** View of Hawthorne Creek (currently listed as Class B), upstream of the BC Hydro ROW pedestrian trail and culvert, facing west.

This section of channel is currently listed as a Class B watercourse (COSMOS 2017). Although no fish sampling was conducted during the survey and no fish were seen, the conditions observed along this section of the watercourse suggest a Class A classification, as no barriers to fish passage were observed. Overall, the habitat value for fish associated with this section of Hawthorne Creek were considered “low”, as a result of limited (if any) spawning habitat, minimal structural or depth complexity present and low flow.

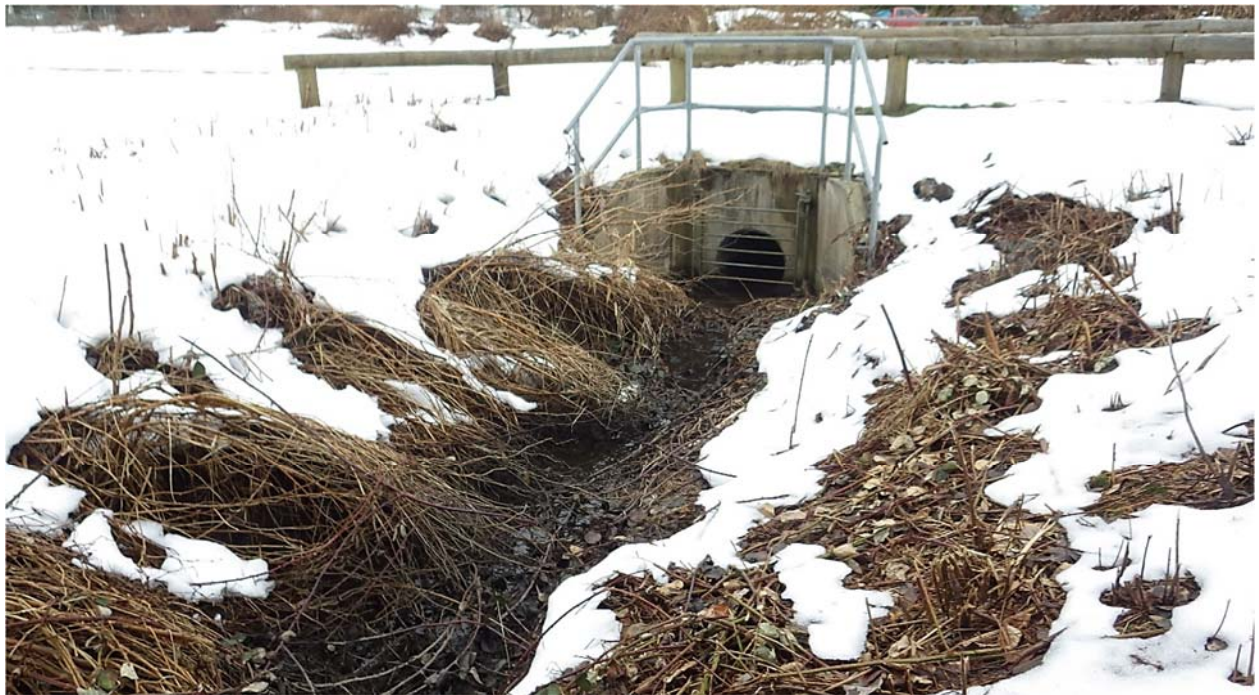
**Photo 4:** View of Hawthorne Creek, downstream of the BC Hydro ROW pedestrian trail and culvert, facing west.

An existing 450 mm culvert (at the trail crossing) will be removed and replaced with a clear span bridge. This culvert removal will require instream work and will result in approximately 38 m<sup>2</sup> of daylighted Class A channel habitat.

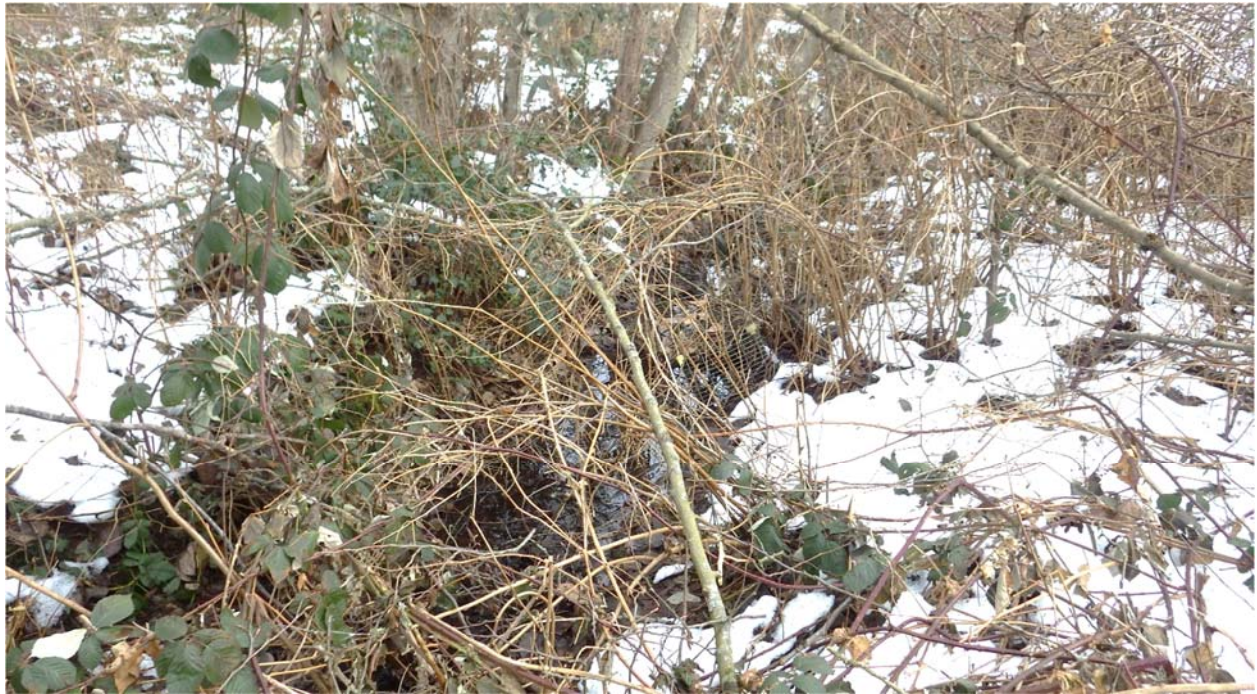
Average channel and wetted widths were 1.5 m and 0.9 m, respectively, with a bankfull depth of 0.15 m (**Appendix B-1, Photo 5**). Substrate was dominated by fine sediment and organic debris. The channel was largely filled with emergent vegetation. The ditch narrows and becomes overgrown approximately 100 m upstream from its confluence with Hawthorne Creek. Riparian vegetation was limited to Himalayan blackberry on the left bank, and red alder (*Alnus rubra*), hardhack and Himalayan blackberry on the right bank. Abundant anthropogenic debris was observed along the channel. Limited flow was observed. Flow is likely dependent overland drainage from the surrounding area.

**Photo 5:** View of Class B drainage ditch along east side of BC Hydro ROW and west side of 140B St (tributary to Hawthorne Creek), facing south.

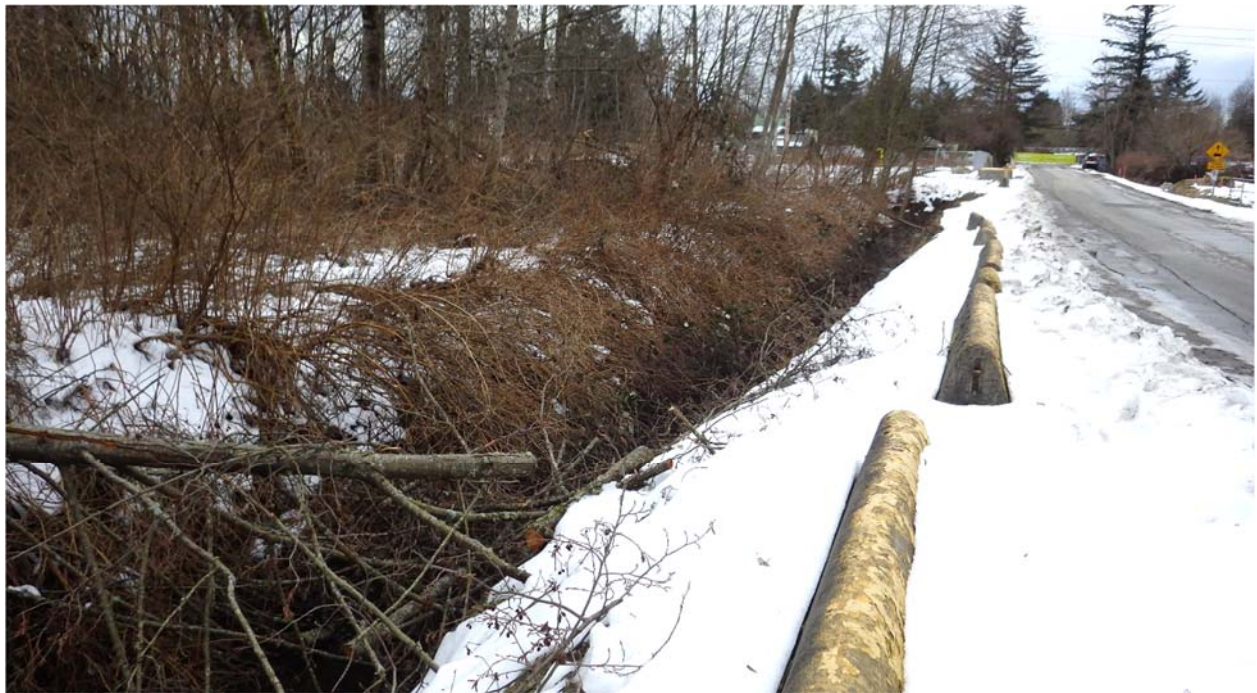
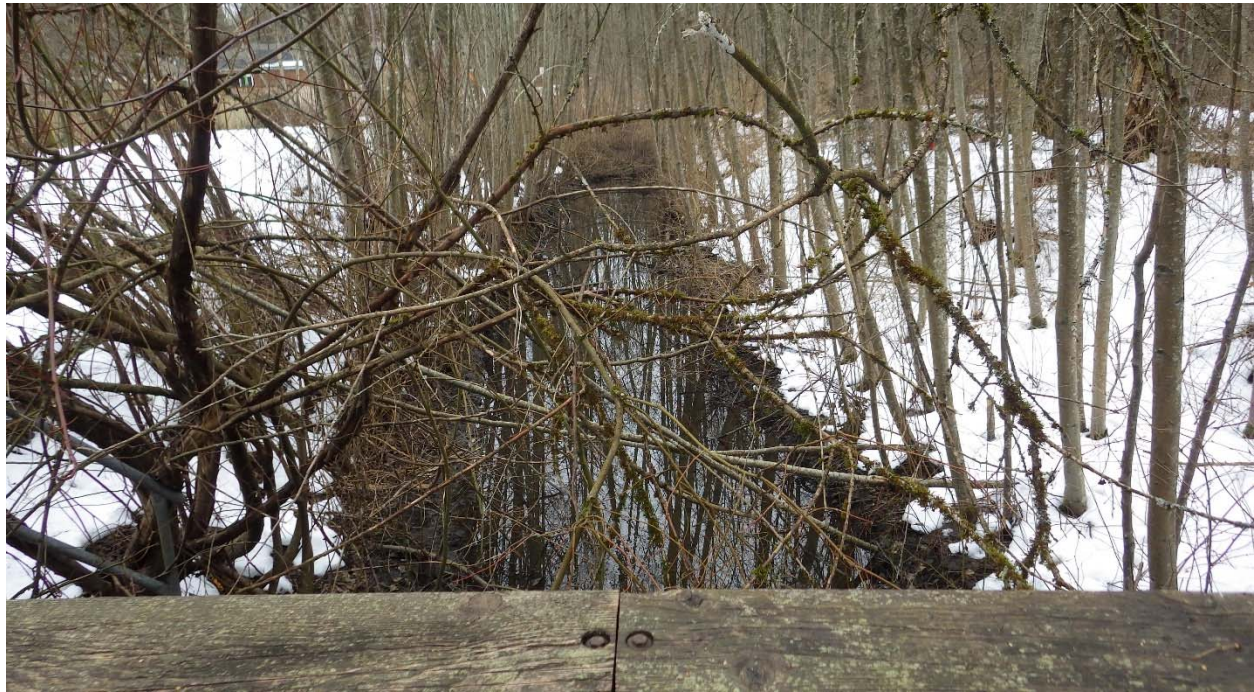
Average channel and wetted widths in this section of Hawthorne Creek were 3.7 m and 2.9 m, respectively, with a bankfull depth 0.35 m and average residual depth of 0.10 m (**Appendix B-1, Photo 6 and Photo 7**). Substrate was dominated by fine sediment and organic debris (i.e., leaf litter), with pockets of sand and small gravel in the vicinity of the culvert at 141 Street. Low flow (unmeasured) was observed. Limited cover (i.e., less than 5% of the channel; RISC 2001) observed in terms of over-stream vegetation, small woody debris and undercut banks. Riparian vegetation consisted almost entirely in red alders (various stages) and shrubs. Seven culverts were observed along this section of Hawthorne Creek: all but one were on the left bank (contributing stormwater drainage from mains along 106 Avenue, and 141, 141A and 142 streets (**Figure 3**). Most of these culverts were concrete pipes (0.6 m in diameter) with concrete headwalls, and had limited flow at the time of the survey (**Appendix B-1, Photo 8**). Fish species with the potential to be present in Hawthorne Creek are discussed in **Section 3.1.1**.

**Photo 6:** View of Hawthorne Creek upstream of 141 Street, facing west (upstream).

**Photo 7:** View of Hawthorne Creek downstream of wooden bridge, facing east (downstream).

This section of Hawthorne Creek is identified as a Class A watercourse in COSMOS (2017). No fish were observed; however, the apparent absence of any barriers to fish movement upstream to this section suggests the classification is appropriate. The habitat value to fish associated with this tributary was “low” as a result of limited spawning habitat, minimal structural or depth complexity present and low flow.

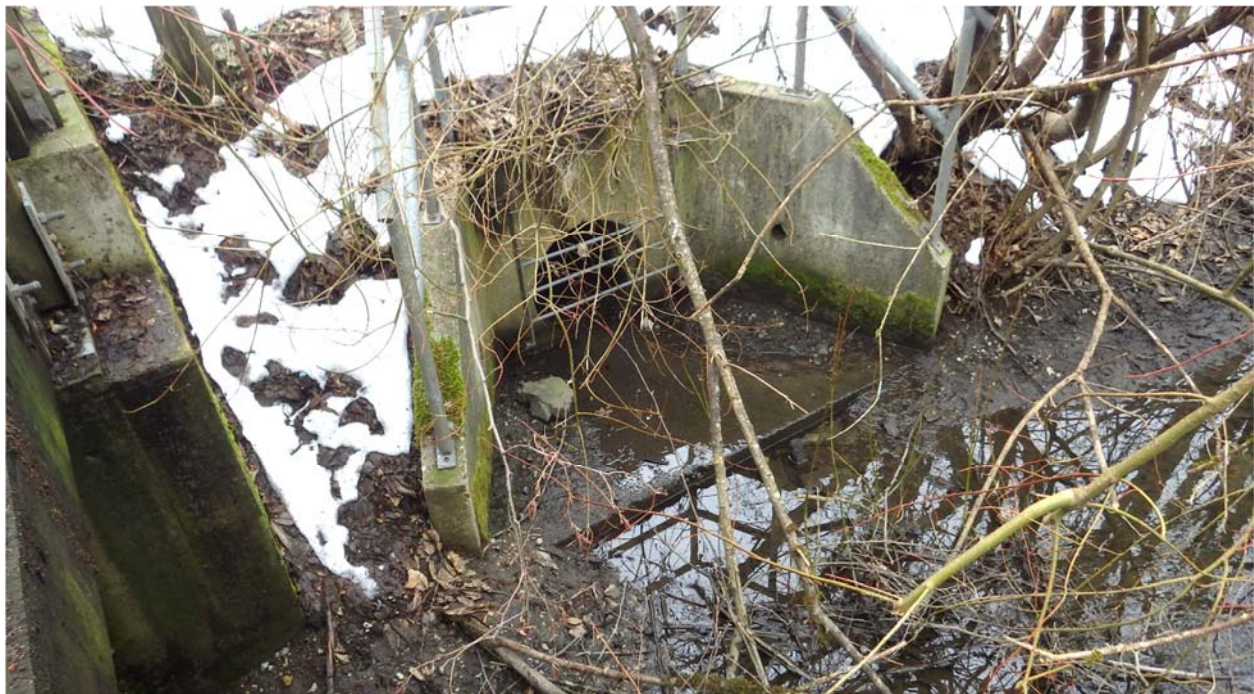
**Photo 8:** View of (one of seven) concrete culvert on Hawthorne Creek long 106A Avenue.

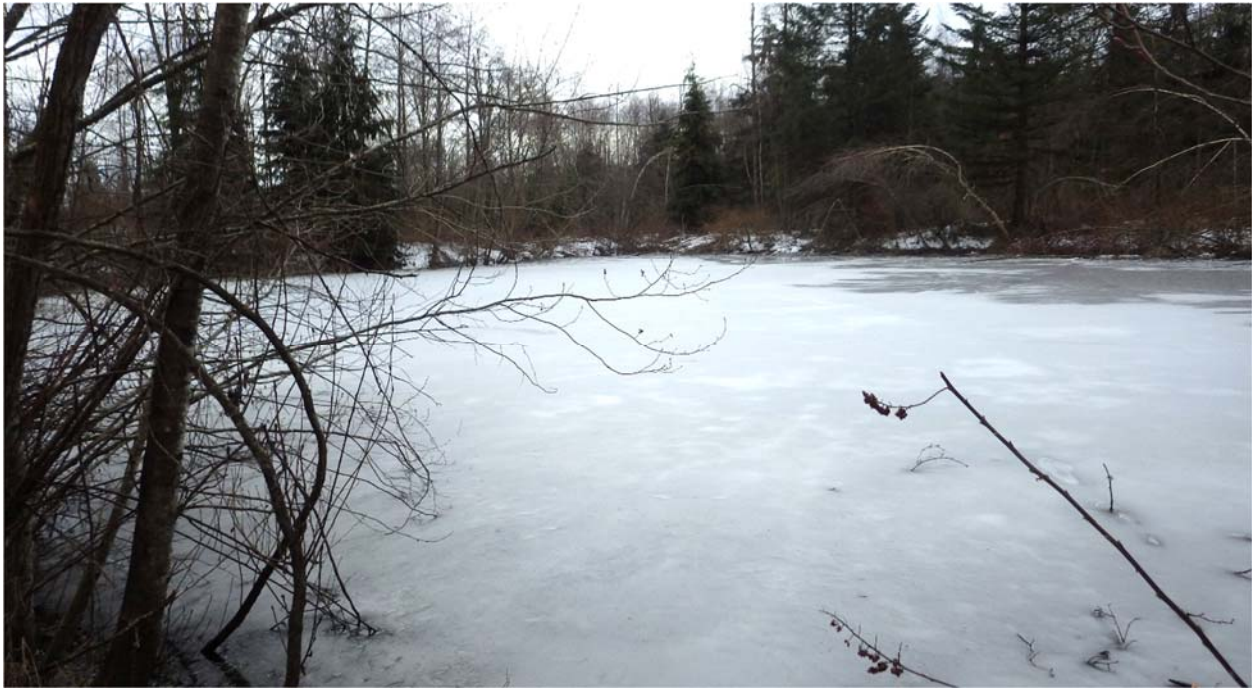
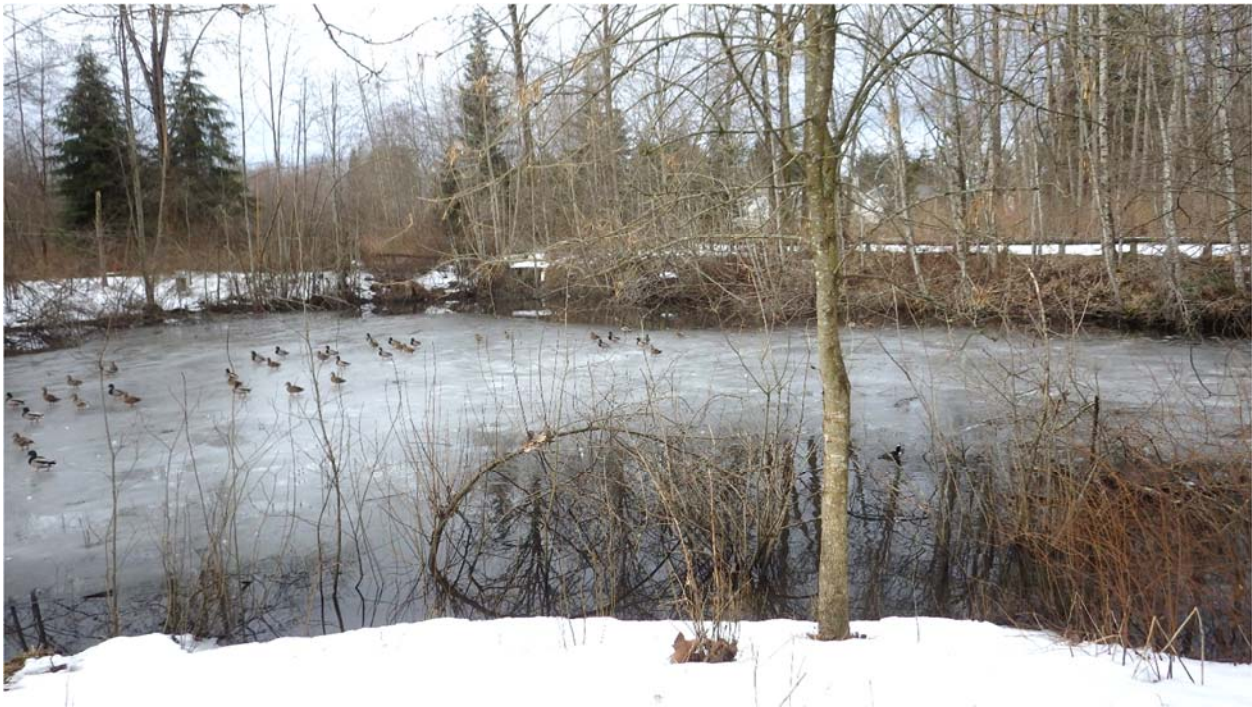
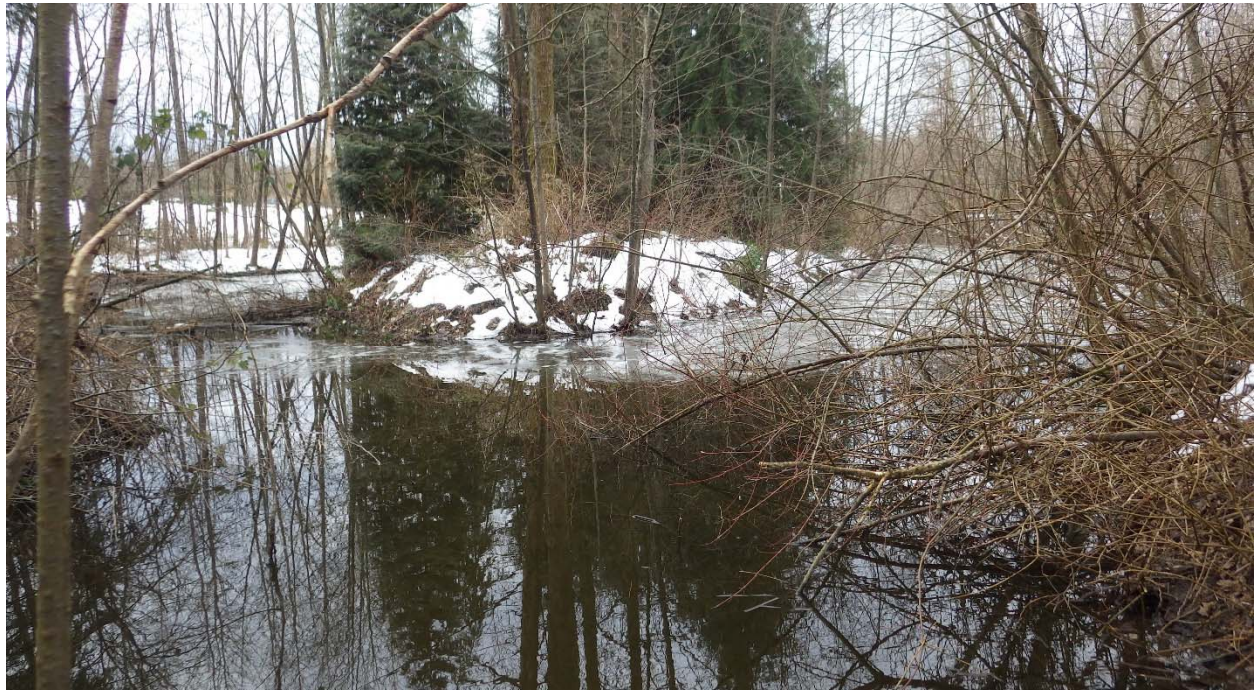
**Photo 9:** View of Bon Accord Lake East – west pond, facing east.

**Photo 10:** View of Bon Accord Lake East – west end of east pond, facing west.

**Photo 11:** View of Bon Accord Lake East – east end of east pond (with island in middle), facing west.

In the absence of information to the contrary, Bon Accord Lake East is considered fish-bearing, consistent with the COSMOS (2017) classification (Class A). Provided the water quality remains acceptable, the two ponds likely provide rearing and over-wintering habitats for salmonids in Bon Accord Creek and Hawthorne Creek. The ponds likely represent “low to moderate” value fish habitat, based on the observed characteristics (depth was not assessed).

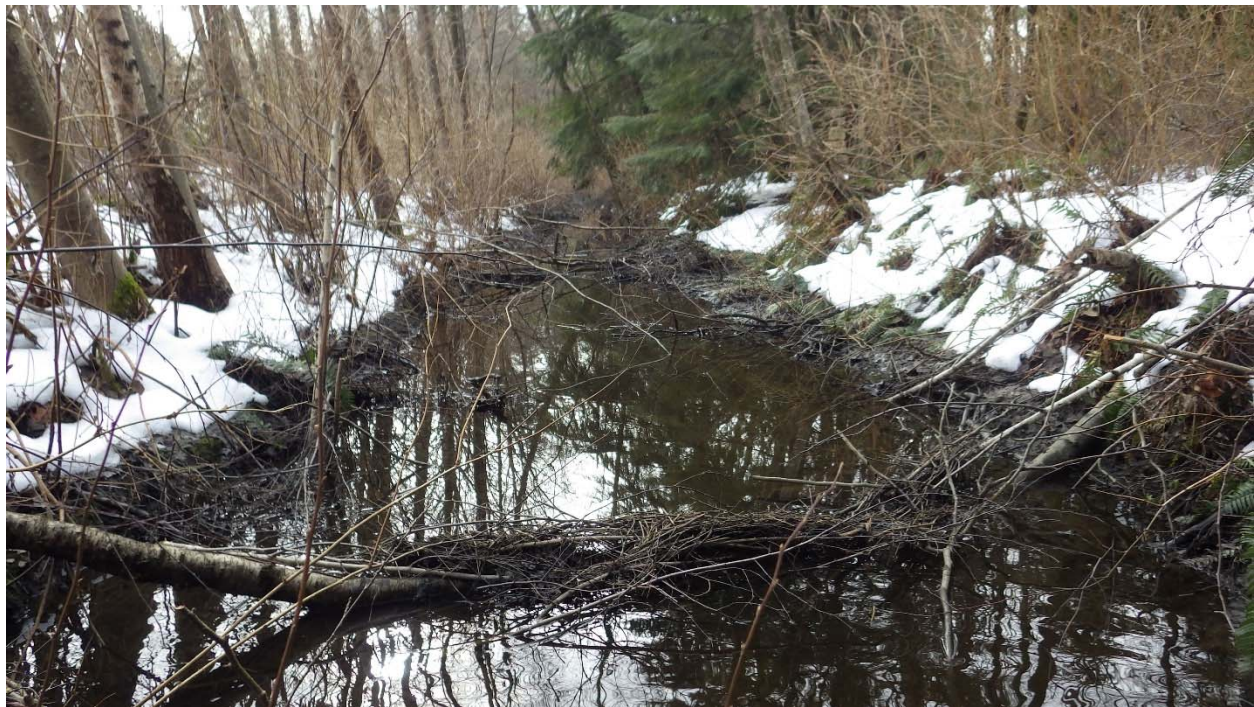
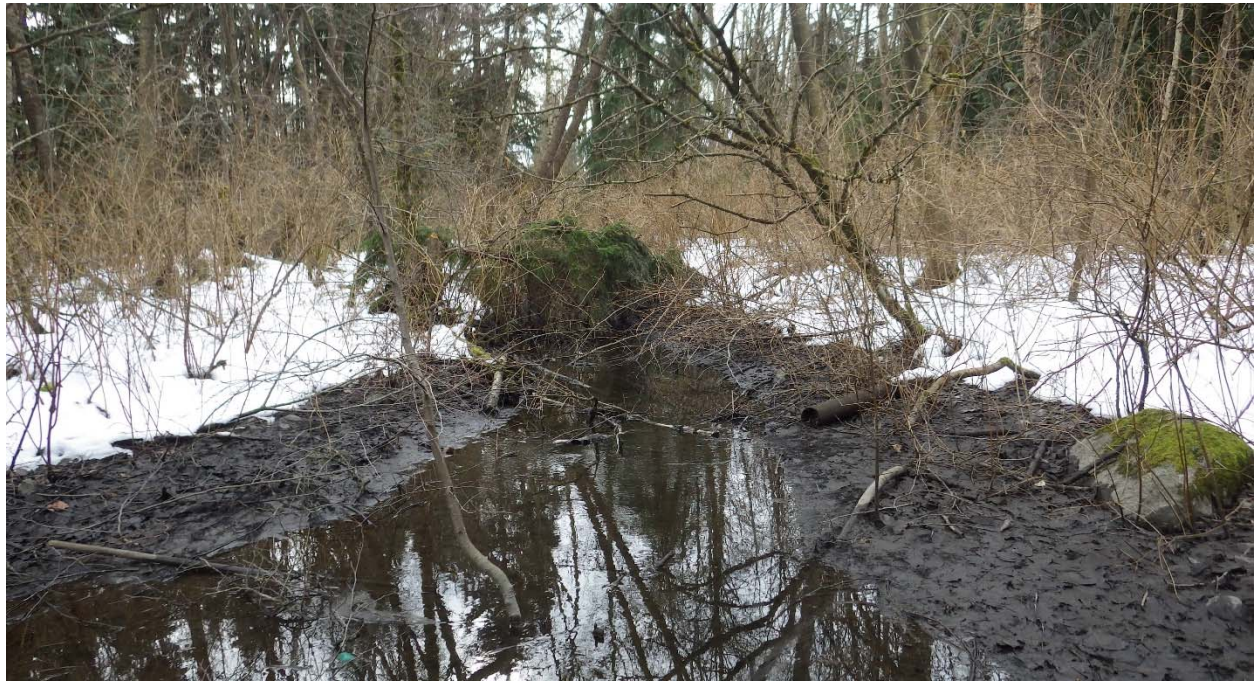
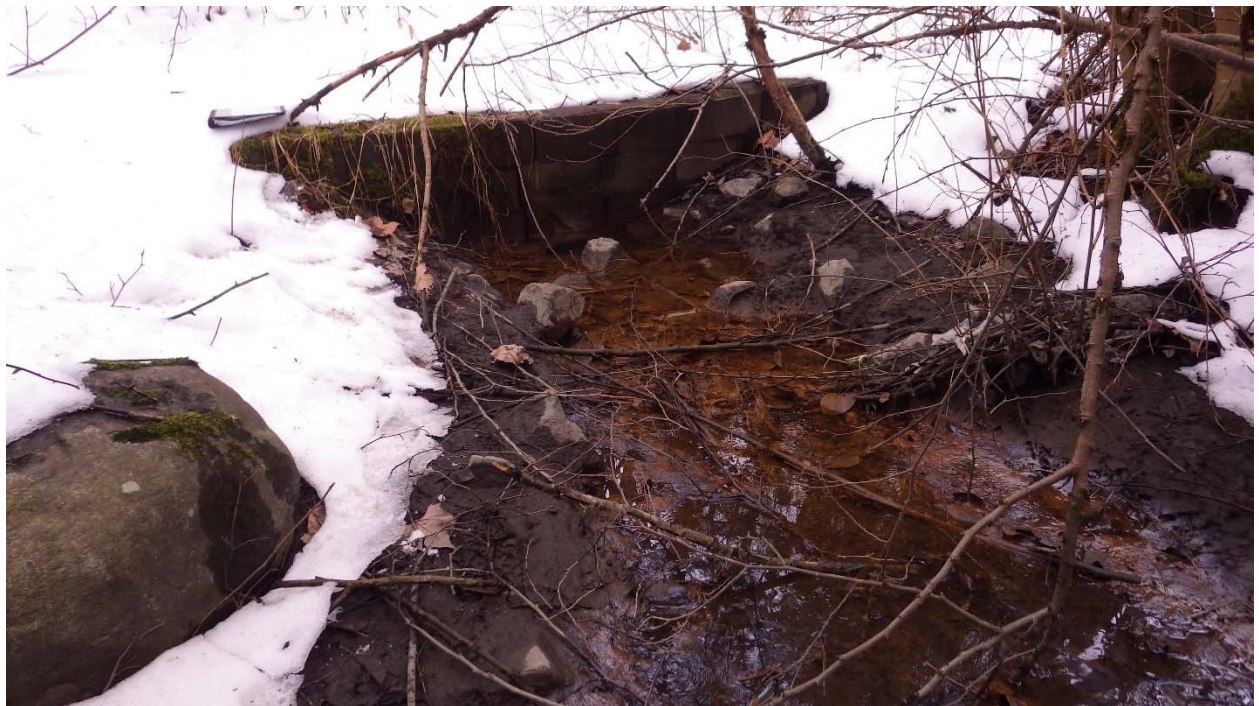
Average channel and wetted widths in this reach were 3.7 m and 2.4 m, respectively, with a bankfull depth of 0.57 m and average residual depth of 0.24 m. Substrate was dominated by fine sediment (mainly silt) and organic debris (i.e., leaf litter), with pockets of sand in the upper 100 m of the creek. Low flow was observed, along with iron deposits (indicating buried organics nearby) and residue on the water surface (**Appendix B-1, Photo 14**). Moderate cover (i.e., 5% to 20% of the channel; RISC 2001) was provided mainly by over-stream vegetation and small woody debris, with occasional undercut banks and deep pools. Riparian vegetation consisted mainly in red alders (various stages), shrubs and ferns, with a few conifers.

**Photo 12:** View of Bon Accord Creek upstream reach: upstream of wooden bridge, facing south (upstream).

**Photo 13:** View of Bon Accord Creek upstream reach: upstream of culvert crossing, facing south (upstream).

**Photo 14:** View of Bon Accord Creek upstream reach drainage pipe and retention wall on right bank, facing east.

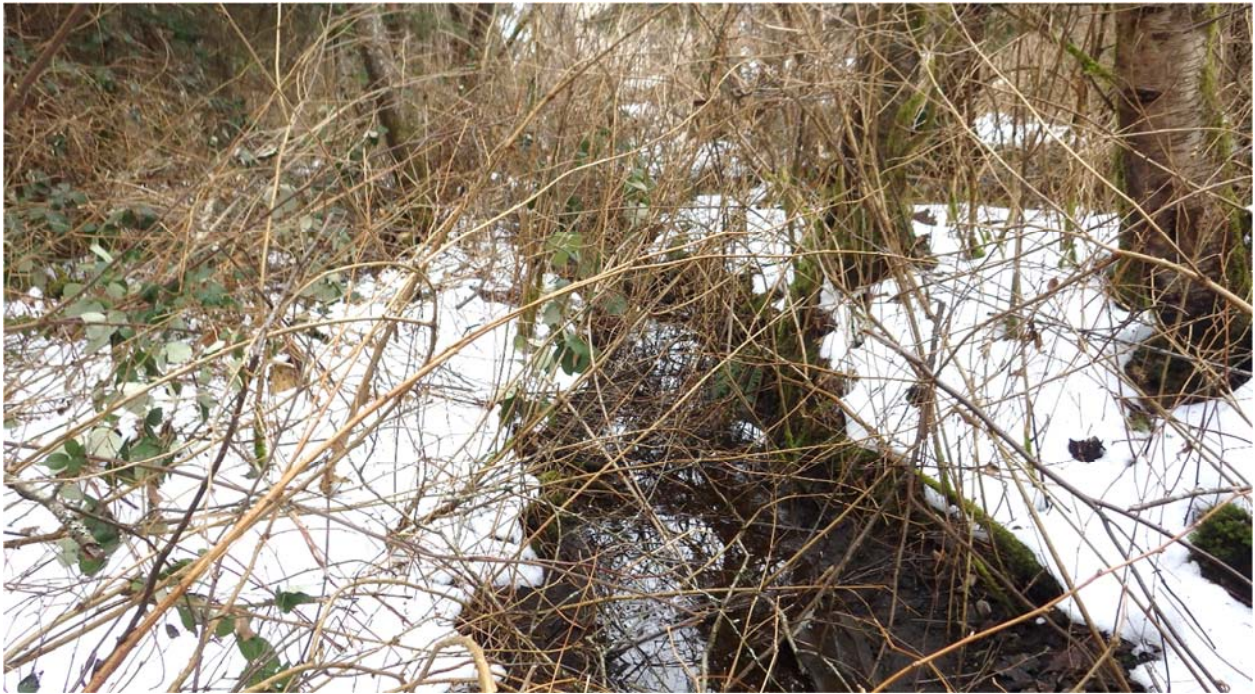
This drainage ditch is approximately 120 m long and is located along the south boundary of Hawthorne Park. This tributary joins Bon Accord Creek approximately 90 m north of 104 Avenue (Figure 3). Average channel and wetted widths were 1.4 m and 0.75 m, respectively, with a bankfull depth of 0.15 m (**Appendix B-1, Photo 15**). Substrate was dominated by fine sediment and organic debris. Limited flow was observed at the time of the survey, and iron precipitate was observed. Riparian vegetation consisted mainly of Himalayan blackberry and red alder.

**Photo 15:** View of Bon Accord Creek Tributary drainage, facing east.

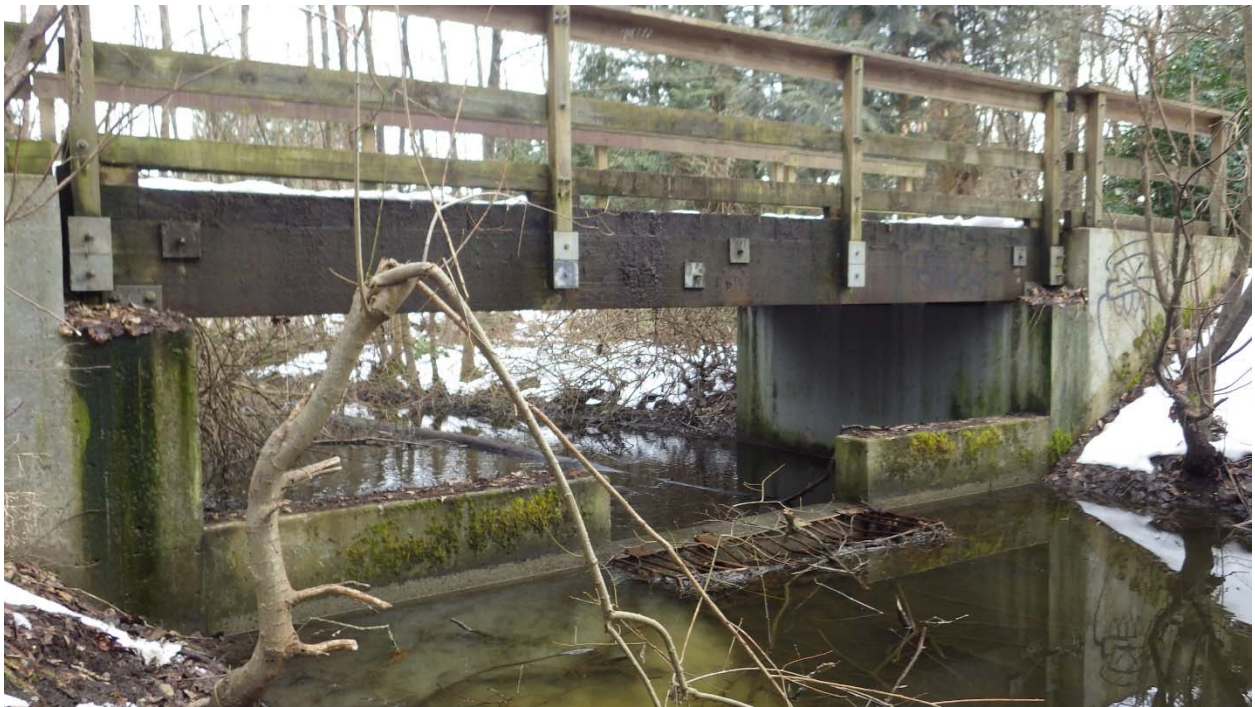
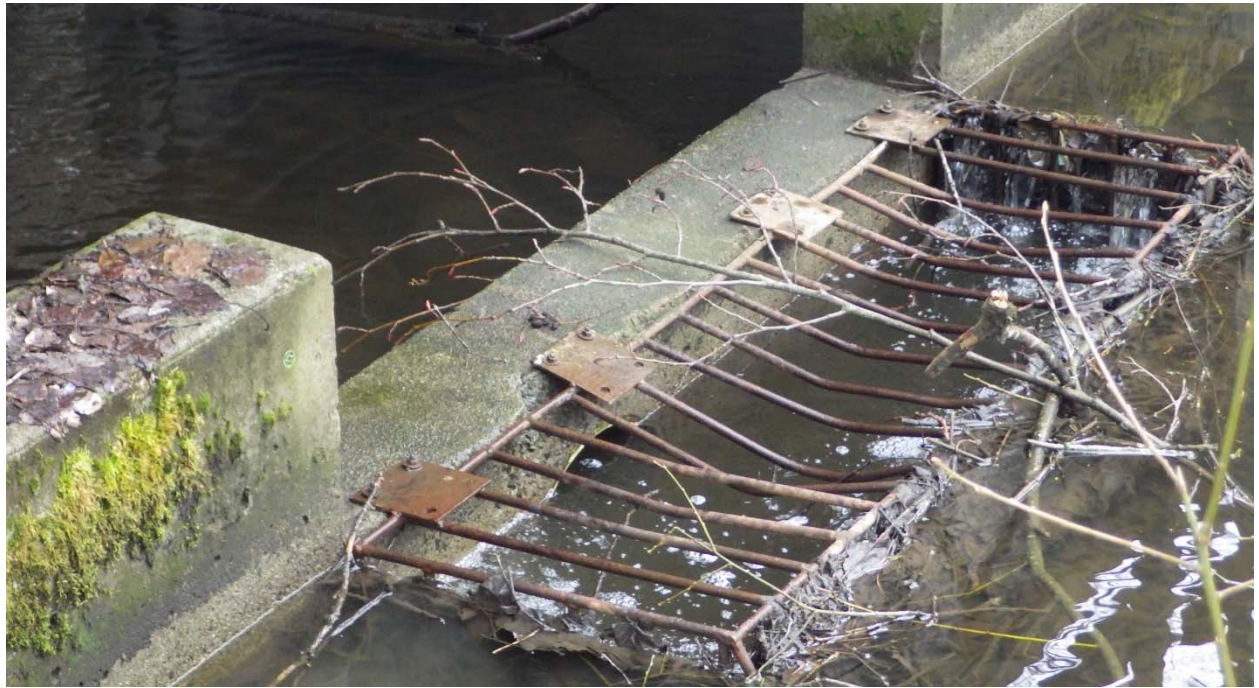
**Photo 16:** View of trail bridge on Bon Accord Creek at Bon Accord Lake outlet, facing east.

**Photo 17:** View of the concrete apron and debris rack at the Bon Accord Lake outlet.

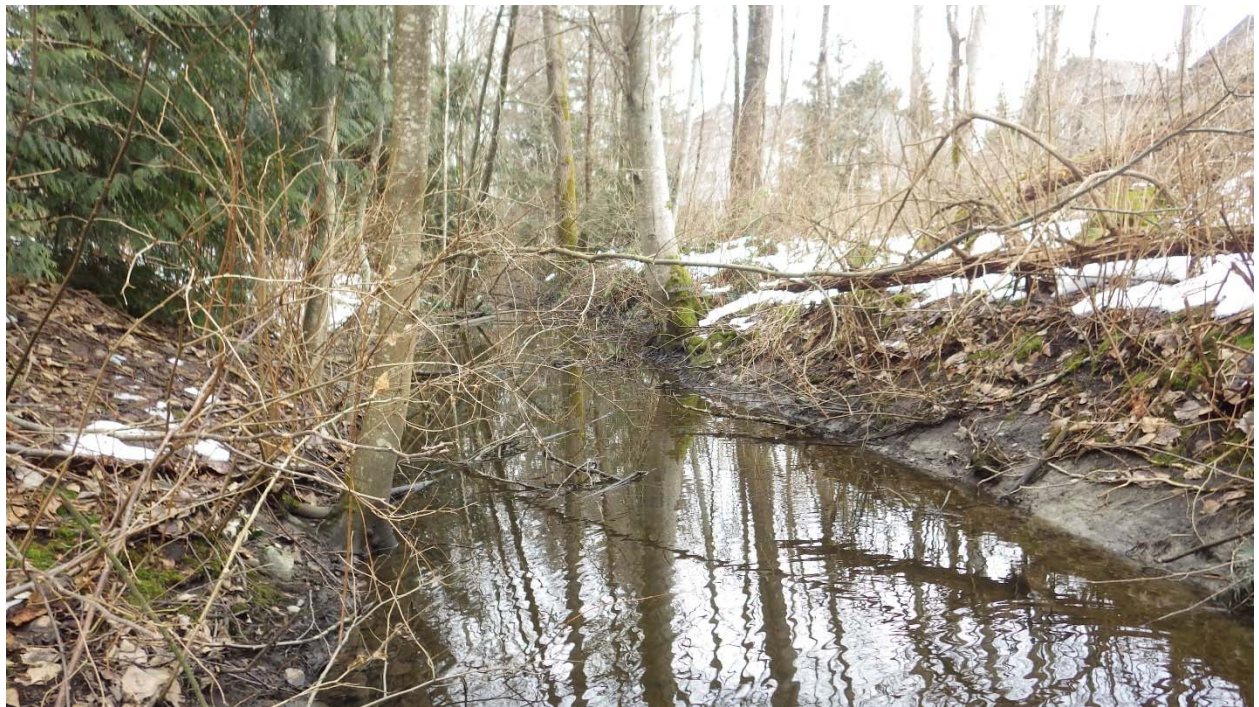
Average channel and wetted widths in the downstream reach were 3.7 m and 3.4 m, respectively, with a bankfull depth of 0.40 m and average residual depth of 0.16 m (**Appendix B-1, Photo 18**). Substrate was dominated by fine sediment and organic debris. Low flow was observed. Moderate cover was provided mainly by over-stream vegetation and small woody debris, with the occasional large woody debris. Riparian vegetation consisted mainly in red alders (various stages), shrubs and a few western redcedar (*Thuja plicata*).

**Photo 18:** View of Bon Accord Creek downstream reach, facing north.

Overall, this surveyed reach of Bon Accord Creek represented “moderate” value fish habitat, with limited observed spawning gravel, high occurrence of fine sediment, and low water levels, but also with some deep pools and moderate cover and complexity. Bon Accord Creek is also considered a channelized watercourse under the Zoning Bylaw, Therefore, a 25 m riparian setback under the Zoning Bylaw applies (**Table 2**).

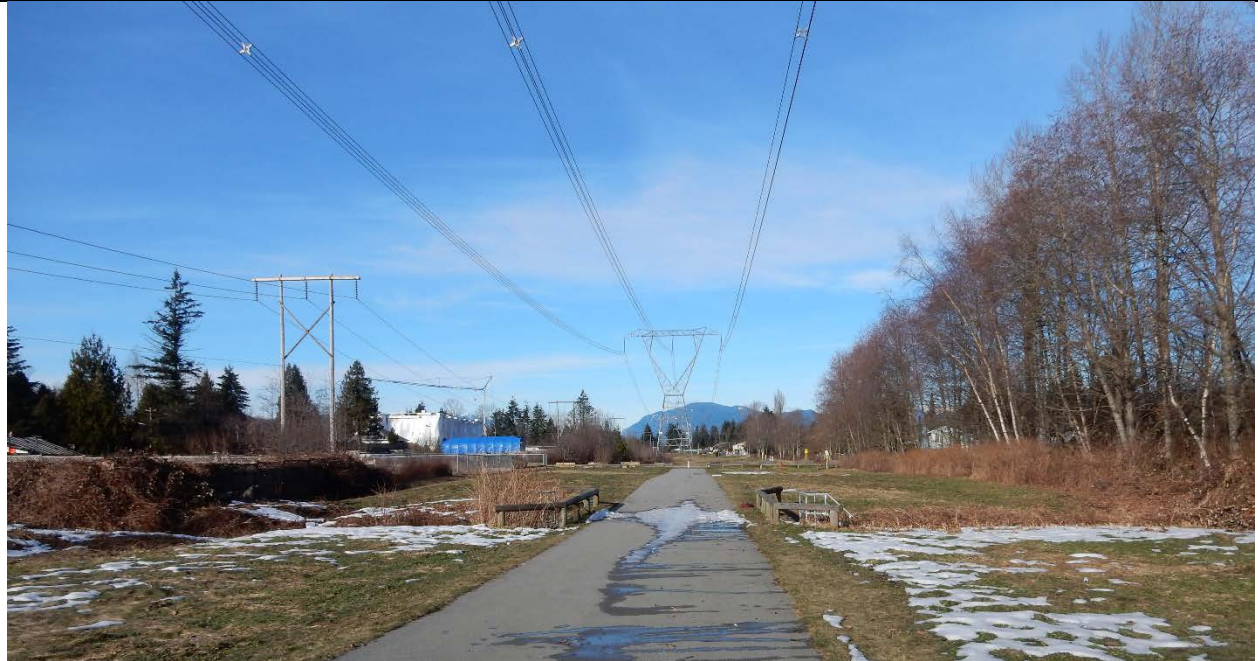
**Photo 1:** View of BC Hydro ROW facing north.

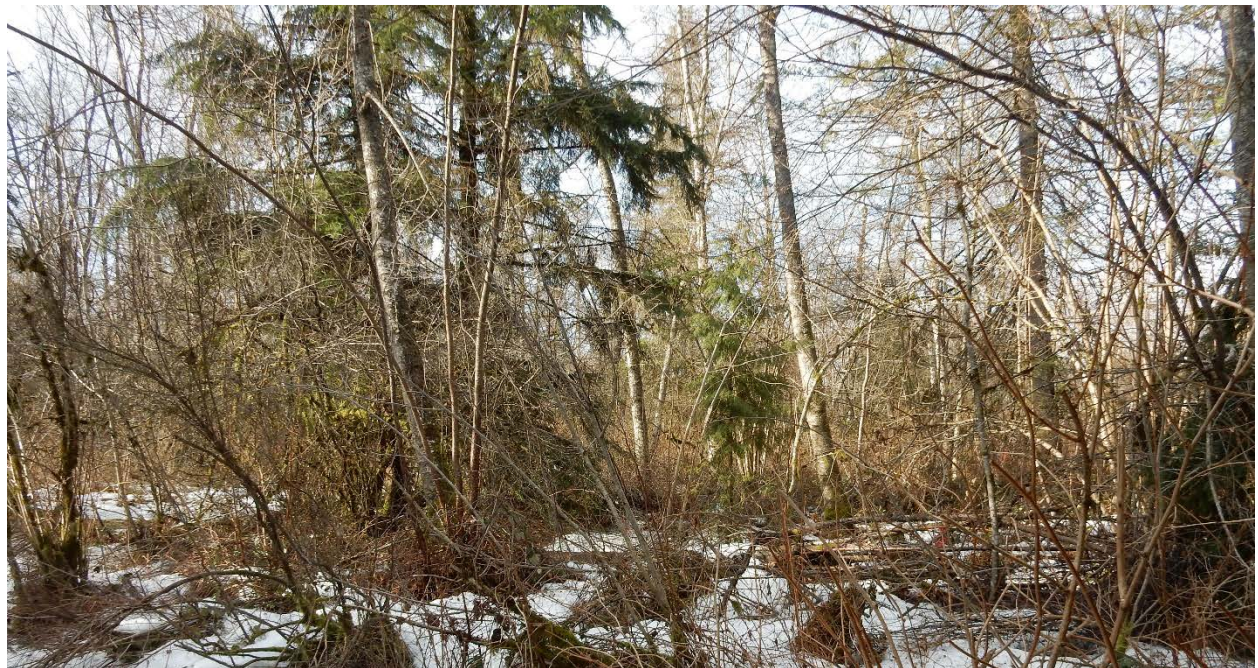
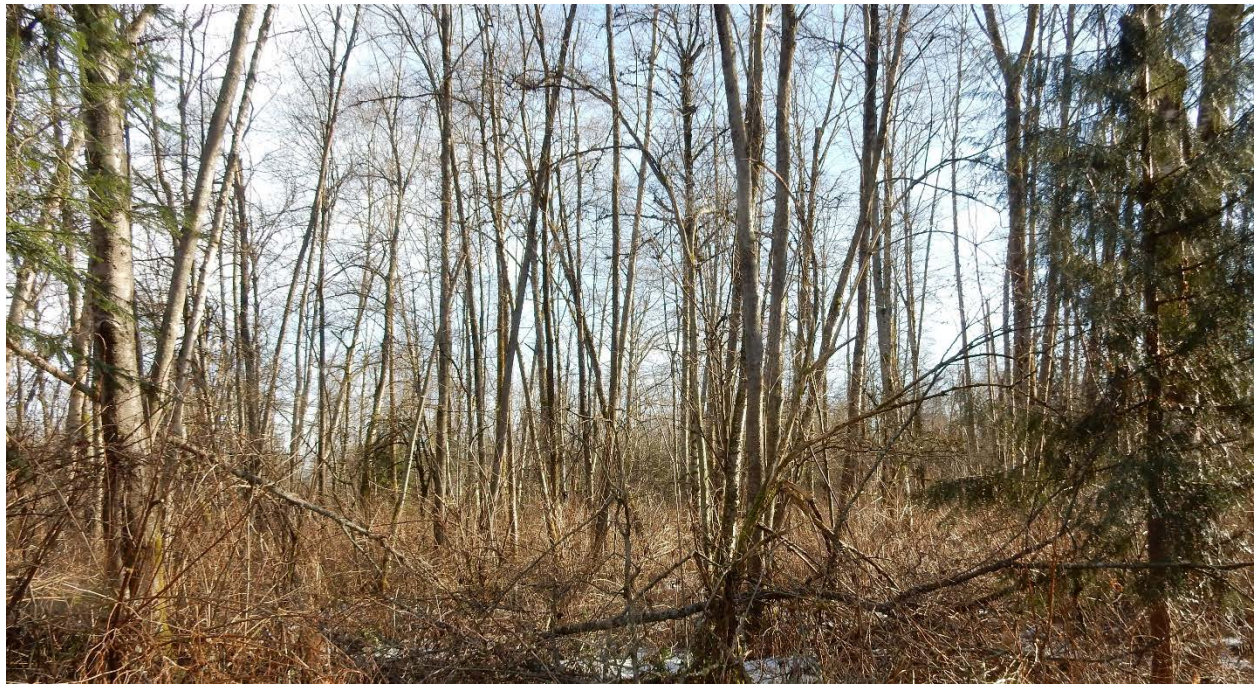
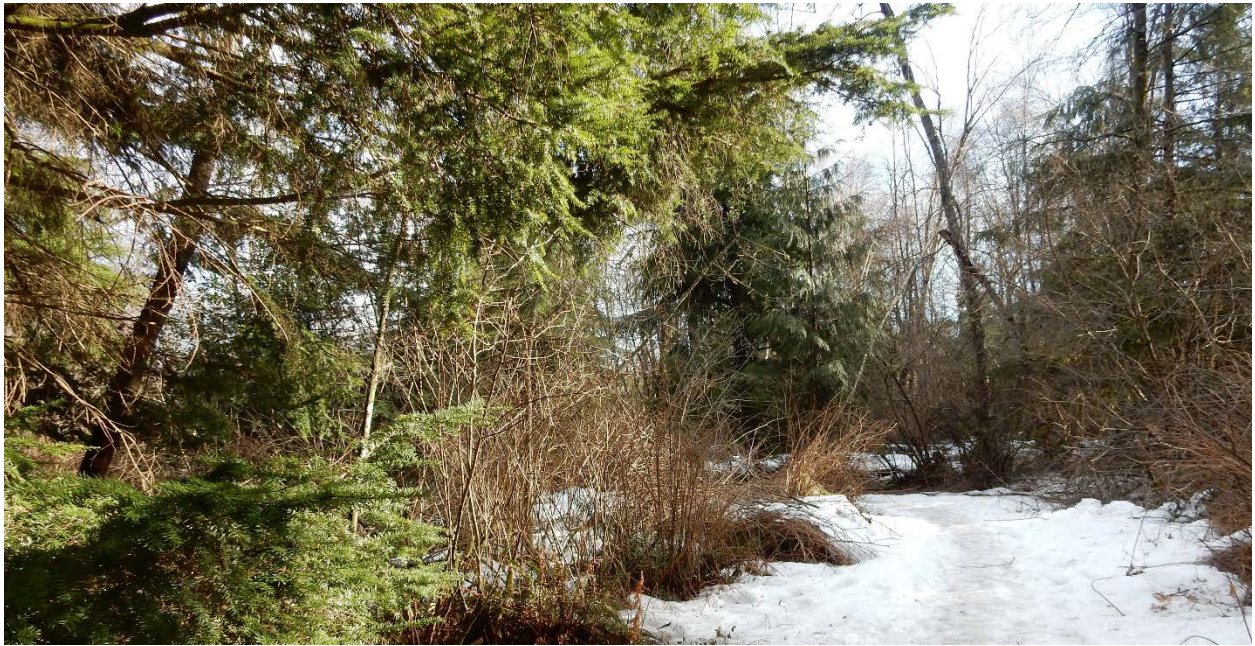
**Photo 2:** Example of dense understorey vegetation in Hawthorne Park.

**Photo 3:** Deciduous forest at west side of Hawthorne Park.

**Photo 4:** Mixed forest at south portion of Hawthorne Park.

Hawthorne Park represents a remnant patch of young, second growth, deciduous forest. Vegetation within the park is representative of rich, moist soils, and young, second-growth deciduous and mixed forest. The north and west portions of the park are deciduous-dominated including black cottonwood (*Populus balsamifera*), and red alder with a dense understorey of shrubs (**Appendix B-2, Photo 2 and 3**). The southern portion of the park has a mixed forest with alder, cottonwood, western hemlock (*Tsuga heterophylla*), and occasional western redcedar and Douglas-fir (*Pseudotsuga menziesii*) (**Appendix B-2, Photo 4**). Understory in these forested areas is a mix of native shrub species including salmonberry (*Rubus spectabilis*), thimbleberry (*R. parviflorus*), red huckleberry (*Vaccinium parvifolium*), sword fern (*Polystichum munitum*), and hardhack.
