# DRAFT REPORT

## 105A Avenue Improvements: Whalley Boulevard to 144 Street

### Environmental Impact Assessment

**Hemmera Envirochem Inc.**

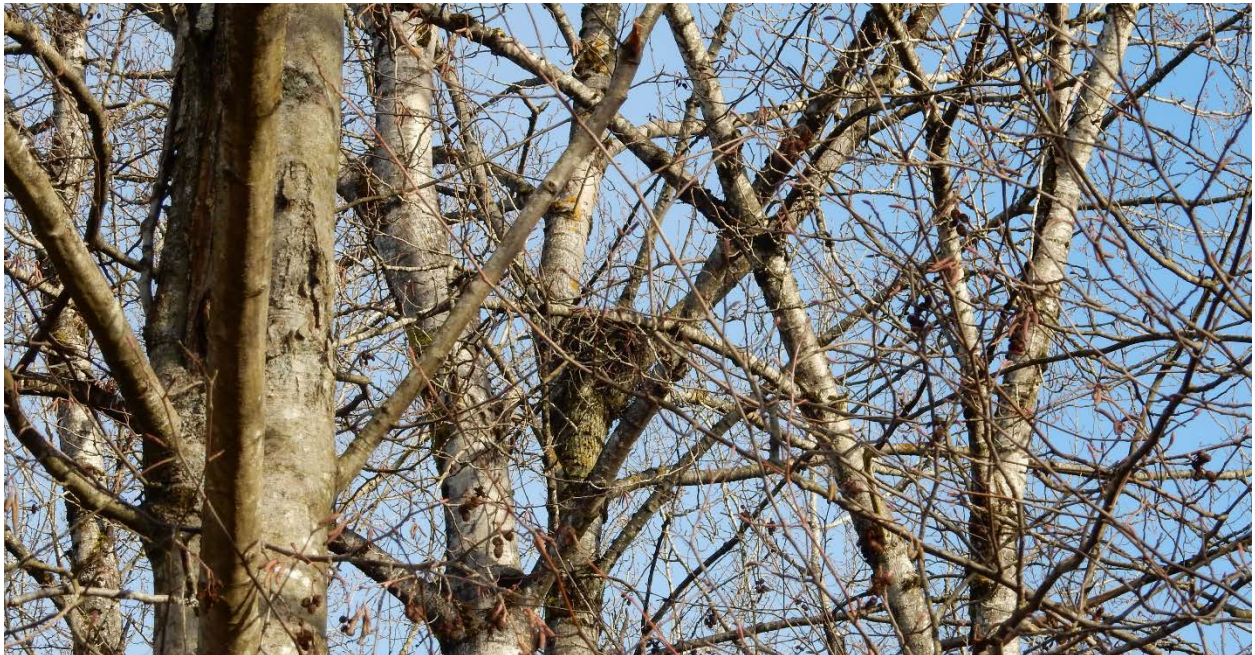
**Photo 5:** Stick nest in cottonwood.

Suitable songbird nesting habitat is available throughout the forested areas of the study area, as well as in several of the hedges and ornamental trees found on residential properties within the study area. Several songbirds were observed in the study area including American robin (*Turdus migratorius*), dark-eyed junco (*Junco hyemalis*), song sparrow (*Melospiza melodia*), and black-capped chickadee (*Poecile atricapillus*). The BC Hydro ROW represents suitable foraging habitat for several species of birds, including raptors such as owls and hawks, which may hunt for small mammals along the ROW. No bald eagle (*Haliaeetus leucocephalus*) or osprey (*Pandion haliaetus*) nests are recorded by the WiTS (2017) within the study area, however a large stick nest, likely a red-tailed hawk (*Buteo jamaicensis*), was noted on the west side of the park at the north end of 104 B Street within a cottonwood tree (**Figure 5, Appendix B-2, photo 5**).
